# **Evaluation of the Potential Impact of Emissions of HFC-134a from Nonprofessional Servicing of Motor Vehicle Air Conditioning Systems**

**CARB Agreement No. 06-341**

**Draft Final Report**

**Prepared for the California Air Resources Board and  
the California Environmental Protection Agency**

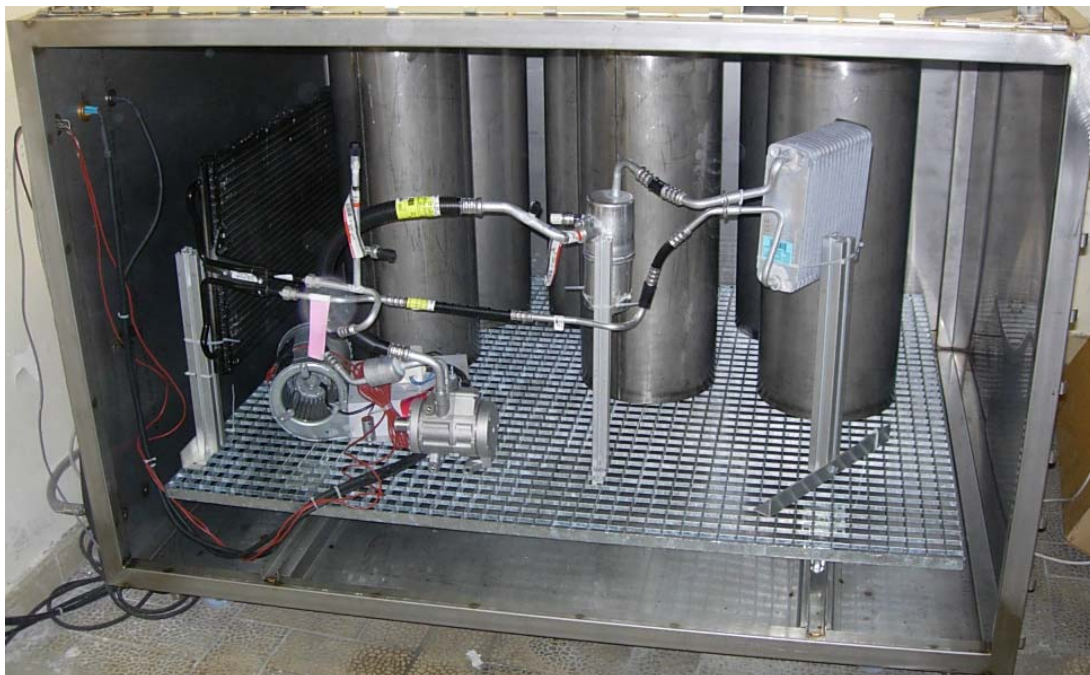
Photo 1.1: Installation of MVAC system in mini-shed.

An infrared photo-acoustic spectroscope, having a detection limit of 15 ppb, measures the refrigerant accumulated inside the mini-shed. The mass flow rate is the product of molar mass and the derivative of the number of moles of HFC-134a along the time in a tight volume (the test chamber). The perfect gas law is used to take into account the small variations of pressure and temperature inside the test chamber. According to Equation (1.2), the following parameters need to be determined for the leak flow rate calculation: the accumulation volume of the test chamber  $V_{accum}$ , the temperature  $T_{amb}$  and the pressure  $P_{amb}$  inside the test chamber, and the evolution of concentration along the time.

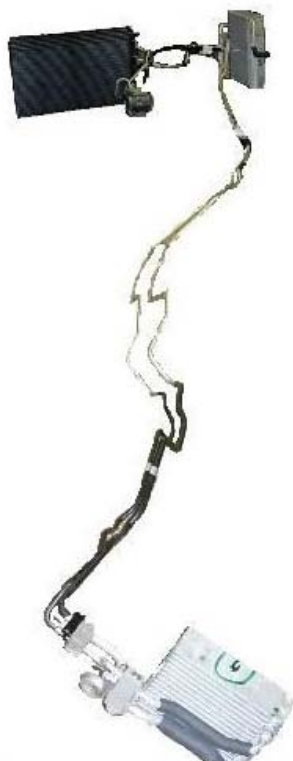
Evaporator 1

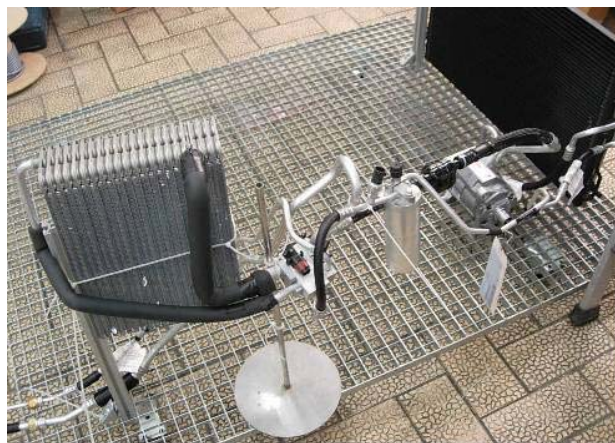
Photo 1.3: Assembled MVAC system B.

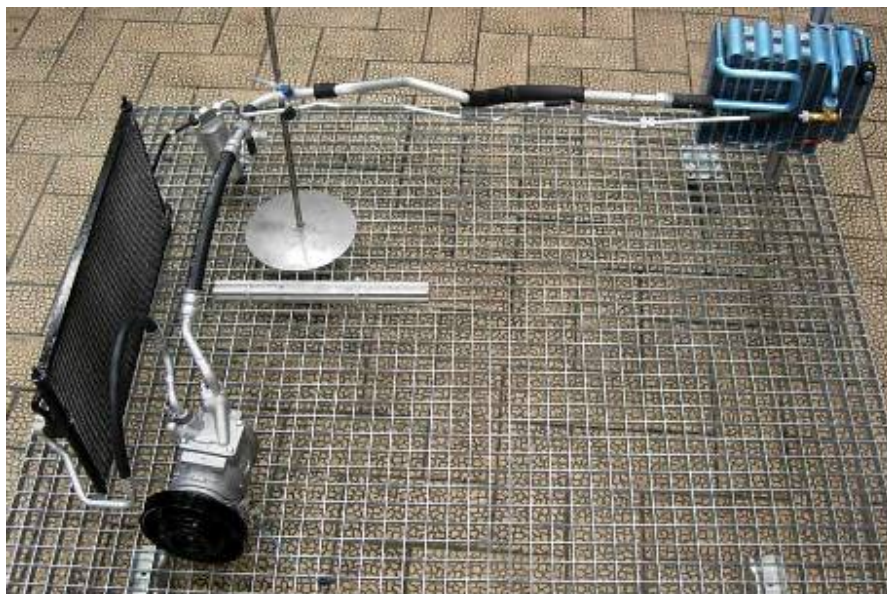
Photo 1.5: Assembled MVAC system D.

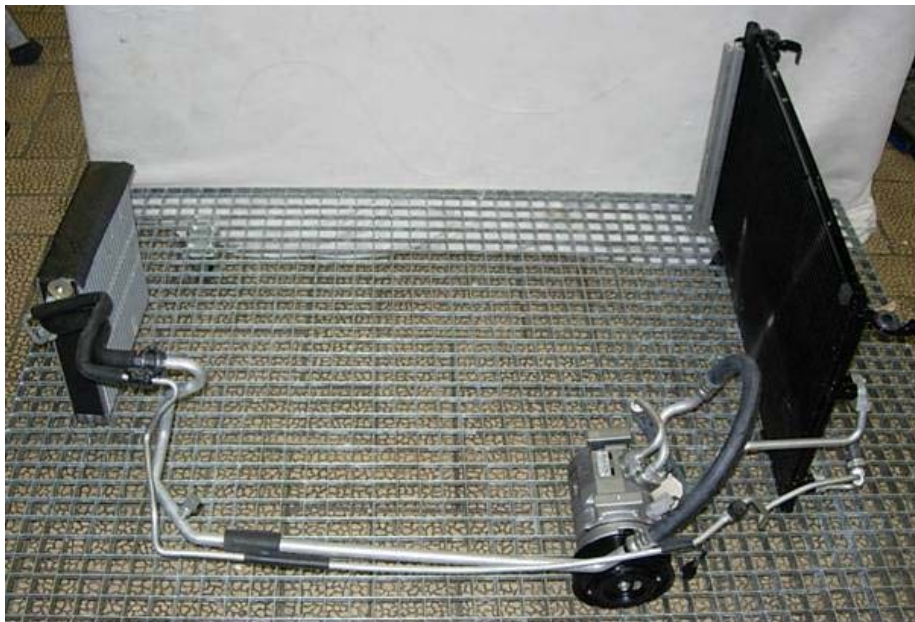
Photo 1.6: Assembled MVAC system D.

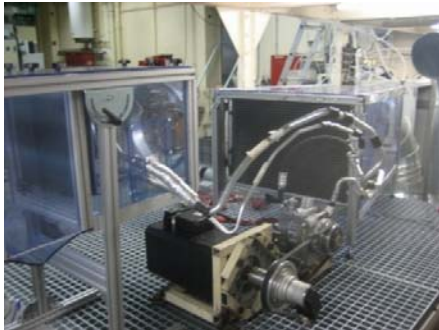
Photo 4.1: General view of the test bench.

The cooling performance change of one of the 5 MVAC systems studied in Section 1 is analyzed along a leaking process. A controlled slow leak is simulated when the MVAC system is operating in steady state regime. The tests are performed at the CEP laboratory using its MVAC test bench (Photo 4.1).

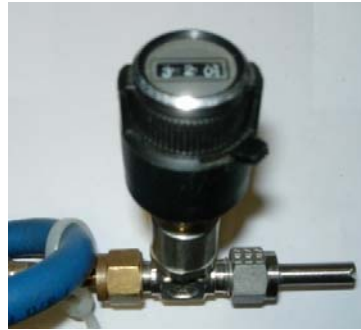
Photo 4.2: Leak valve with micro counter.

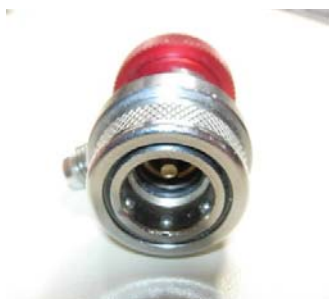
Photo 4.3: Quick coupler - Connection with moving rod by screwing fastened with clips.

In contrast, the quick couplers with a fixed rod open the gates at the moment they are connected. Photos 4.4, 4.5 and 4.6 show three types of quick coupler with fixed rod fastened with clips.

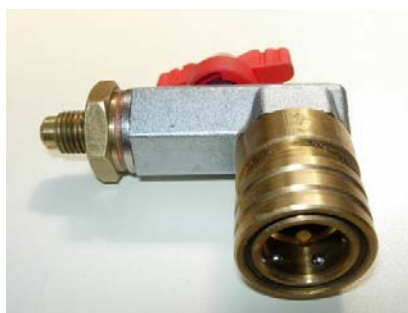
Photo 4.4: Quick coupler - connections with fixed rod fastened with clips equipped with ball valve.

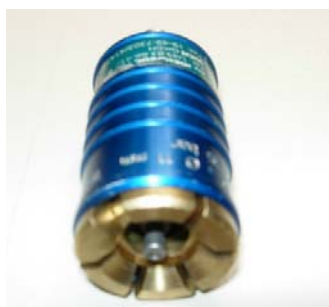
Photo 4.5: Quick coupler - connections with fixed rod fastened with clips.

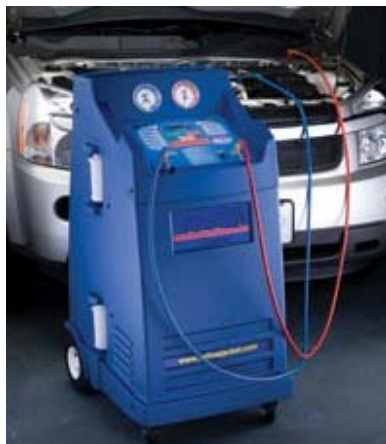
Photo 4.7: Automated machine in service.

Usually, the automated machines perform the whole procedure without action by the professional (recovery, evacuation, leak test, and recharge). The machine is connected to the system via HP and LP service valves. The quick couplers used are usually with a moving rod, allowing thus good leak tightness. The connection between the machine and the system is set once.

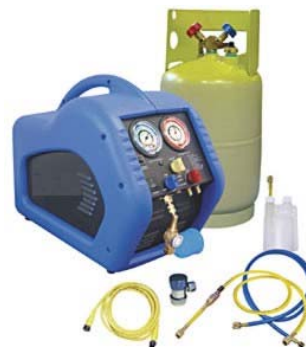
Photo 4.8: Recovery machine and cylinder.

- a recovery machine,
- a recovery cylinder,
- a manifold,
- a vacuum pump

Thus, the possible number of connecting/disconnecting actions could be as high as ten and so emissions are higher.

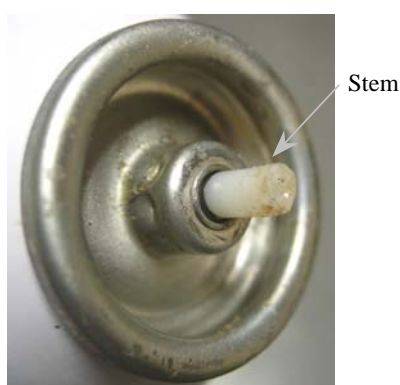
Photo 4.10: Valve plate with a self-closing valve.

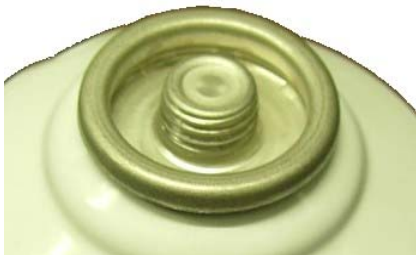
Photo 4.12: Valve plate of an S&P can.

- A self-closing valve inserted in the valve plate (type V, see Photo 4.10), or
- A valve that is screwed and perforates the valve plate (type S&P, see Photo 4.12).

The **screwed and perforated** cans have a different valve plate that incorporates an externally threaded portion coupled with the valve plate (see Photo 4.12). This portion has a wall that will be penetrated by the pointer of a valve. The S&P cans are proposed in different capacities: 12, 13, 14, and 18 oz.

The **shut-off valve** is screwed on the can valve plate (see Photo 4.12). After that, the user turns the handle and the pointer moves downward and penetrates the valve plate wall releasing the refrigerant. To isolate the container, the user must continue turning the handle until the pointer reaches the maximum displacement and contacts the valve central body. Valve isolation is achieved by using an elastomer seal between the valve and the container valve plate, and a metal-to-metal contact between the pointer and the valve central body (see Photo 4.13).

The shut-off valve technology has a very low impact on refrigerant emissions and, for the charging kit *F4-02*, has no impact at all. The high performance of the shut-off valve is related not only to the use of just two seals, but also to the applied load in both seals. One of them is metal-to-metal (see Photo 4.12).

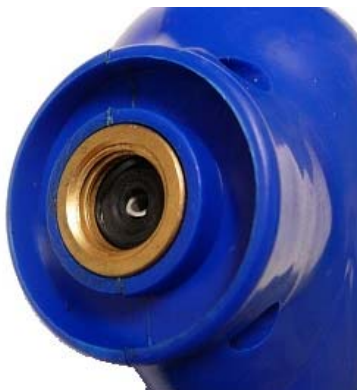
Photo 4.14: Rubber seal and pointer of a push button valve.

The **push button valve** is also screwed on the can valve plate, but has a different perforating mechanism from the shut-off valve. As user screws the valve, a pointer penetrates the valve plate wall and the refrigerant automatically flows to the valve. The valve is tightened by using four different seals (see Photo 4.15). When the handle is squeezed, the refrigerant is transferred to the flexible hose and once the handle is released, the valve and the container are isolated.

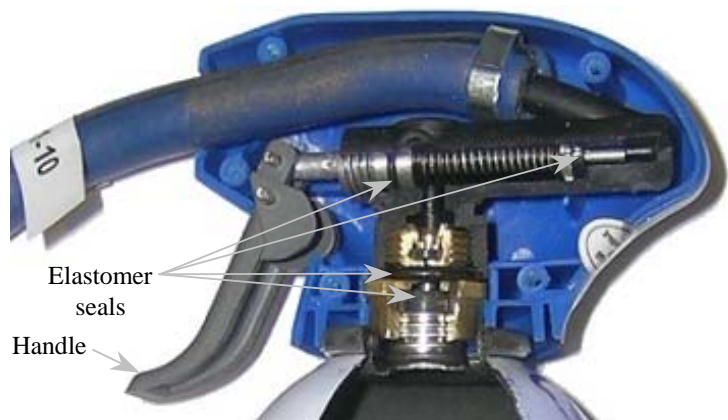
Photo 4.15: Sectional view of a push button valve.

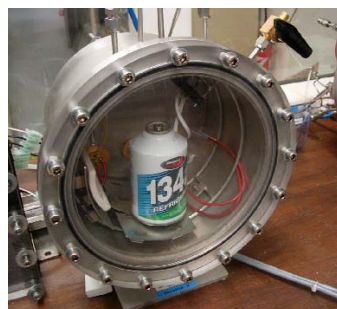
Photo 4.16: Accumulation volume where refrigerant annual leak is measured

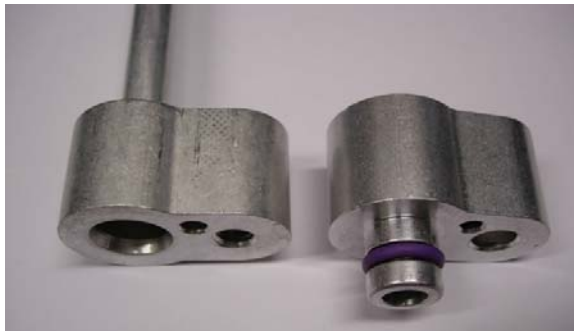
Photo 4.17: Fittings technology used for this comparative study.

Five fittings with the same design and different LFRs have been chosen (see Photo 4.17). They are composed of two flanges and one o-ring seal, and put together with a screw.

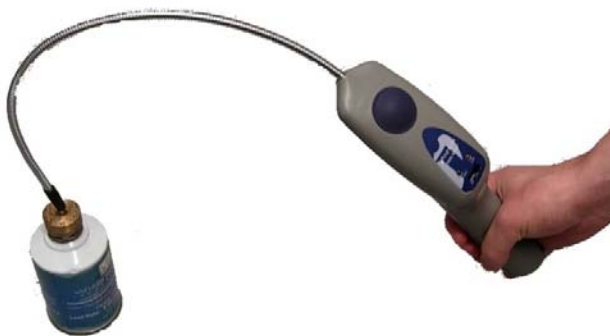
Photo 4.18: Calibrated leak for checking the ELD.

Before the leak search, the ELD is checked with a calibrated leak of 6 g/yr (see Photo 4.18).

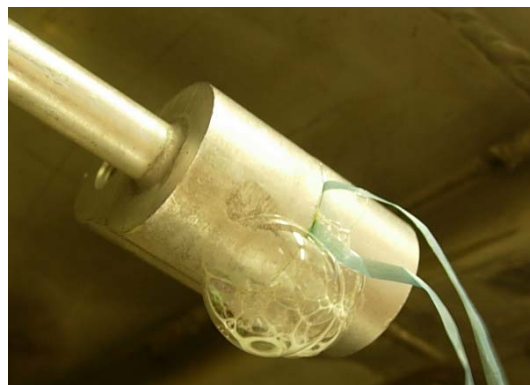
Photo 4.21: Leak detection with soap bubble (1200 g/yr).

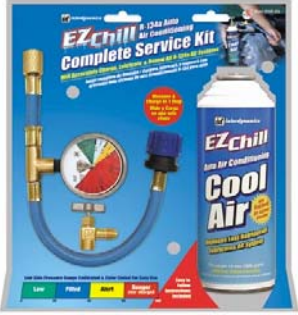
RGM-2CS	S&P In Line Gauge	14 oz. 11 oz. of R-134a 2 oz. of Ester Lubricant with O-Ring Conditioner 1 oz. AC Cleaner and Leak Sealer

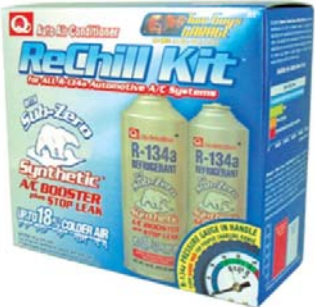
The image shows a box for the QUEST ReChill Kit. The box is blue and white with red and yellow accents. It features the text 'ReChill Kit' in large blue letters, 'QUEST' in red, and 'R-134a' in yellow. It also mentions '4 Oz of Sub-Zero Synthetic A/C Booster' and '2 x 18 oz. of R-134a'. There is a picture of a car and a person using the kit.	QUEST ReChill Kit	S&P	2 x 18 oz. of R-134a 4 Oz of Sub-Zero Synthetic A/C Booster
